The aim of the study was to use AFM for imaging the surface pathology of the sperm exposed to heat treatment.

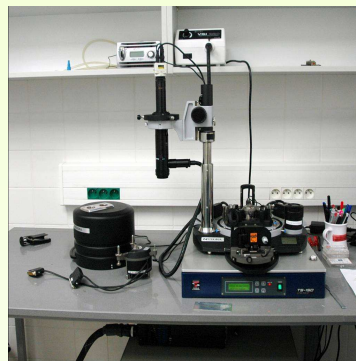
Fig. 2: Atomic Force Microscope NTgera Vita (NT-MDT)

Atomic Force Microscope NTgera Vita (NT-MDT) was used to characterize spermatozoa morphology within a nanometer scale (Fig. 2).

Scanning head type SFC050LNTF designed for scanning by probe (maximal operation area 100x100x10 μm) equipped with a holder for operation in a liquid was used for all experiments. Glass slide with immobilized spermatozoa was fixed to the bottom of plastic Petri dish and the internal volume was filled with sterile isotonic solution of sodium chloride. Samples imaged in contact mode at ambient temperature were scanned by using silicon nitride probe with 0.01 N/m elastic constant at 0.25 Hz scanning speed. Surface topography and spatial distribution of electrical potential gradient on the sample surface were measured and recorded simultaneously, thus providing more complex understanding to the surface morphology. The defects were detected and recorded.

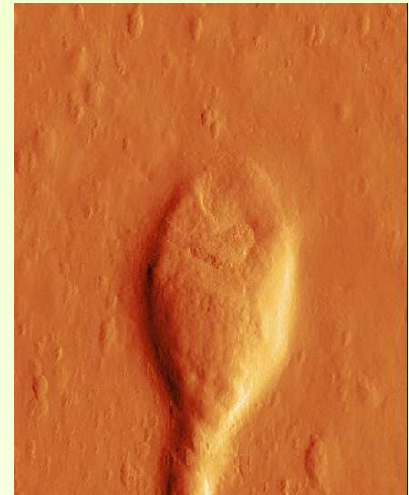
Fig. 3: Tiny surface defects of sperm after 30 minutes heating at 40.0 C.

The obtained images clearly show both normal sperm head (Fig. 3) and defects of the surface of spermatozoa exposed to heating. After 30 minutes heating at 40.0 C only tiny surface defects were observed, after heating at 50.0 C most of the sperms were nearly damaged.
